Manhole Inspection Summary

Manhole # S31C__022MH

Insp Date: **8/8/08 12:01 PM**

Location Address: **300 w saratoga st**

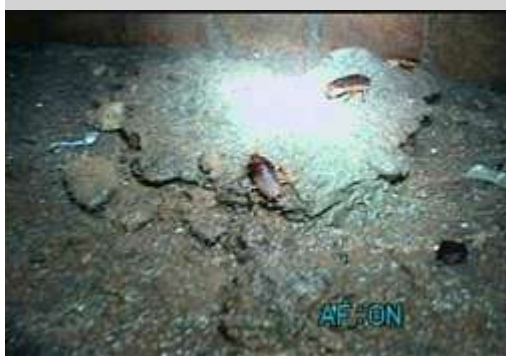
Condition: ☒ Sound ☐ Cracked ☐ Root Intrusion ☐ Deteriorated ☐ Leaks ☐ Debris

bench debris

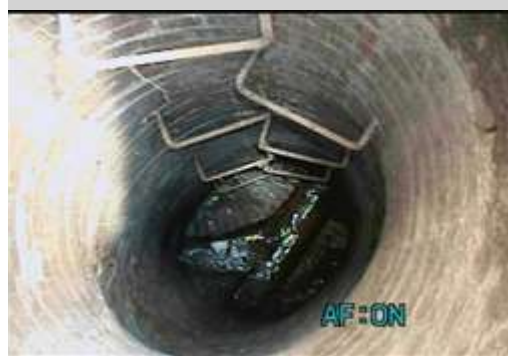
Defect 5

Count: **7** Missing: **0** ☒ **Corroded**

steps

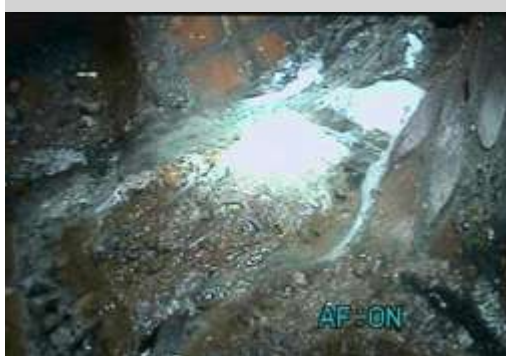
Defect 3

Condition: ☐ Sound ☐ Cracked ☐ Root Intrusion ☐ Deteriorated ☐ Leaks ☒ **Debris**

channel debris

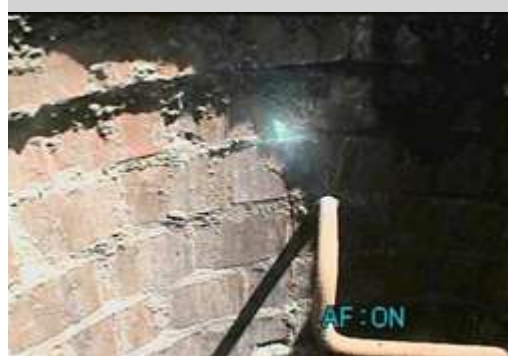
Defect 2

Condition: ☐ Sound ☒ **Cracked** ☐ Root Intrusion ☐ Loose Brick ☐ Deteriorated

crack in corbel

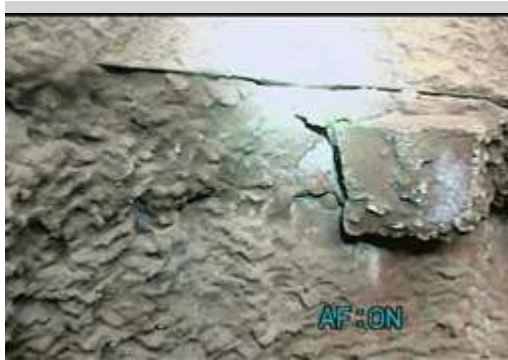
Defect 1

Condition: ☐ Sound ☐ Cracked ☐ Root Intrusion ☒ **Loose Brick** ☐ Deteriorated

loose brick
